Proceedings IRF2018: 6th International Conference Integrity-Reliability-Failure Lisbon/Portugal 22-26 July 2018. Editors J.F. Silva Gomes and S.A. Meguid Publ. INEGI/FEUP (2018); ISBN: 978-989-20-8313-1

STABILITY EVALUATION OF MARBLE STONE CLADDING AFFECTED BY BOWING AND WIND PRESSURE- A CASE STUDY

Rui Sousa^(*), Hipólito Sousa

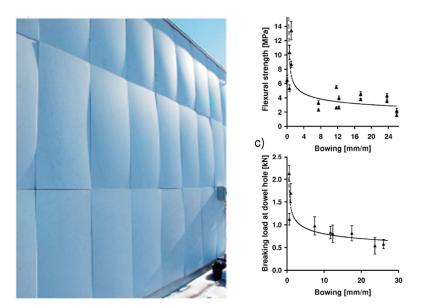
This bowing/deflexion is irreversible, increases over time and causes the loss/degradation of the stone mechanical strength (Figure 1), usually faster in the beginning and slower over time (Logan, 2006).

Fig. 1 - Examples of bowing occurring in stone marble façade (Loughran et al, 2007) and decay of resistance VS bowing of marble (Koch, 2004)

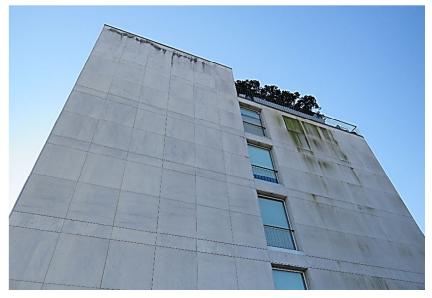
Fig. 2 - Partial view of the stone cladding applied on the north façade of the building

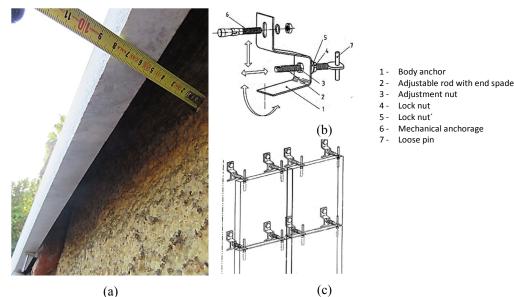
Fig. 3 - Construction details of the cladding system: (a) detail view of cladding after removal of a stone slab (b) dowel anchorage system; (c) fixing points

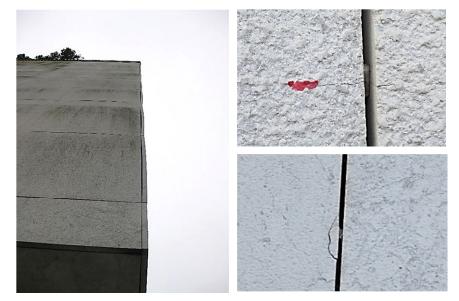
According to an inspection performed on the building facade, the bowing was affecting more than 50% of the cladding system, and in some marble slabs there were measured permanent deflexions with 8 to 12mm (or 6 to 7 mm/m). No damage/fracture patterns were visually detected in the central part of the slabs with bowing, however, near some fixing points (dowel holes) of some slabs fracture patterns were found (Figure 4).

Fig. 4 - Examples of bowing and local damage/fracture detected on the marble slabs

However, the load capacity at the dowel hole is not verified for slabs located higher than 9m, therefore presenting a high risk of occurring damage/fracture in the stone at the dowel hole (as observed in the inspections made - see Figure 4).

Since the bowing causes irreversible damage on the marble slabs, the recommended and most usual intervention is to remove the affected slabs and replace them with marble less susceptible to bowing (satisfying the criteria of EN 16306), or using another type of natural or artificial stone.
