SOUND, NOISE AND SPEECH AT THE 9000-SEAT HOLY TRINITY CHURCH IN FATIMA, PORTUGAL

António P.O. CARVALHO, Pedro M.A. SILVA

University of Porto, Faculty of Engineering, Laboratory of Acoustics
Portugal
carvalho@fe.up.pt

noise control '10

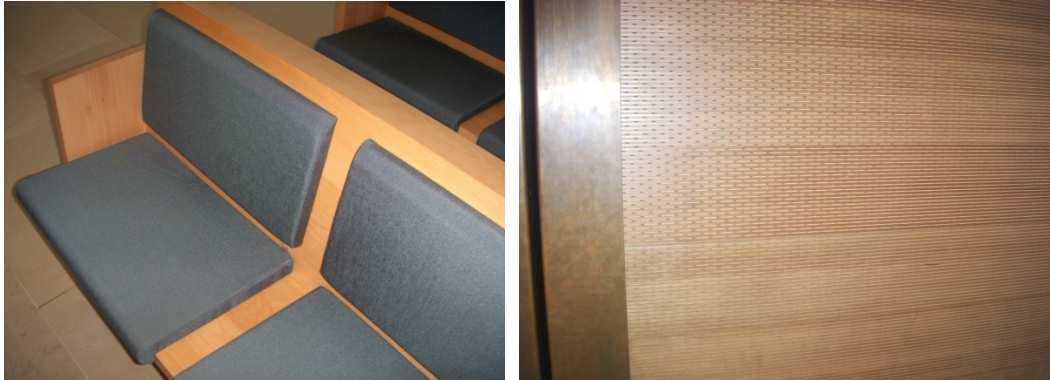
Figure 4 and 5 – Cushioned pews (left) and perforated panels (right).

- Pews in wood with acoustically tested soft cushions (fig. 4);
- Interior faces of the twelve entrance doors with a perforated wooden finishing (grouped resonators) (fig. 5);
- Choir rear wall and rear assembly wall with diffusers (fig. 6 and 8);
- Presbytery wall with a slight inclination;
- Sidewalls covered with acoustical material *Akustaplan* (fig. 9);

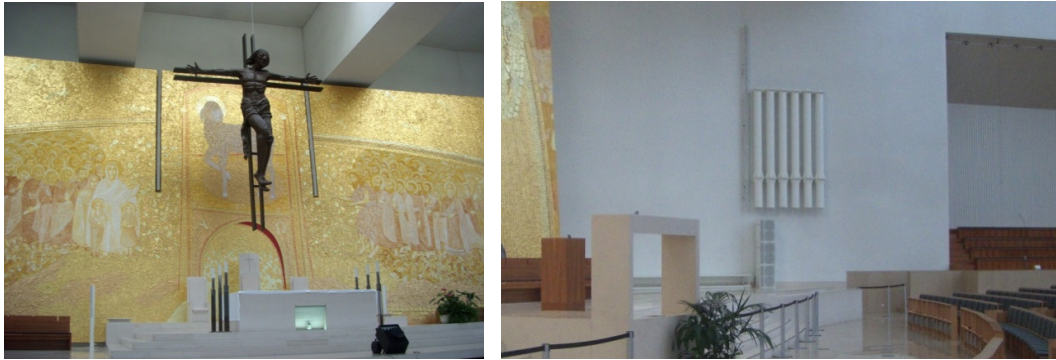
Figures 10 and 11 – Suspended loudspeakers (left) and loudspeakers and *Wave Cannons* for the organ (right).

To all these, joins an electro-acoustics sound reinforcement system (SRS) with *Bose* loudspeakers and BSS processing. There are two columns with five loudspeakers, suspended at the center of the altar (fig. 10), responsible for the speech diffusion. At the altar right side six columns and four for low frequency, responsible for the organ amplification and also six wave cannons for extension of organ sound (fig. 11).
