SOUND, NOISE AND SPEECH AT THE 9000-SEAT HOLY TRINITY CHURCH IN FATIMA, PORTUGAL

António P.O. CARVALHO, Pedro M.A. SILVA

University of Porto, Faculty of Engineering, Laboratory of Acoustics
Portugal
carvalho@fe.up.pt

noise control '10

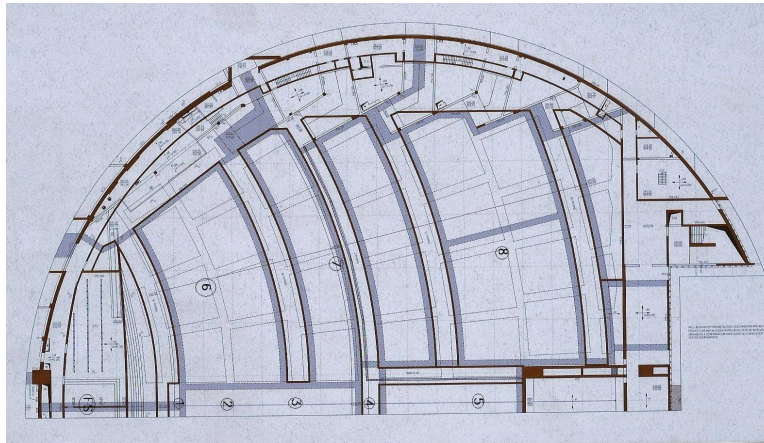
Figure 3 – Holy Trinity church floor half plan with RASTI measuring positions (altar at bottom left).

- L (sound pressure levels) (and Noise Criteria NC) of the background noise with and without the HVAC equipment working (five measure points used);
- RASTI (Rapid Speech Transmission Index) noise with and without the use of the sound reinforcement system (eight measure points used, fig. 3);
- Reverberation Time (RT) by octave bands (125 to 4k Hz) (nine measure points used).

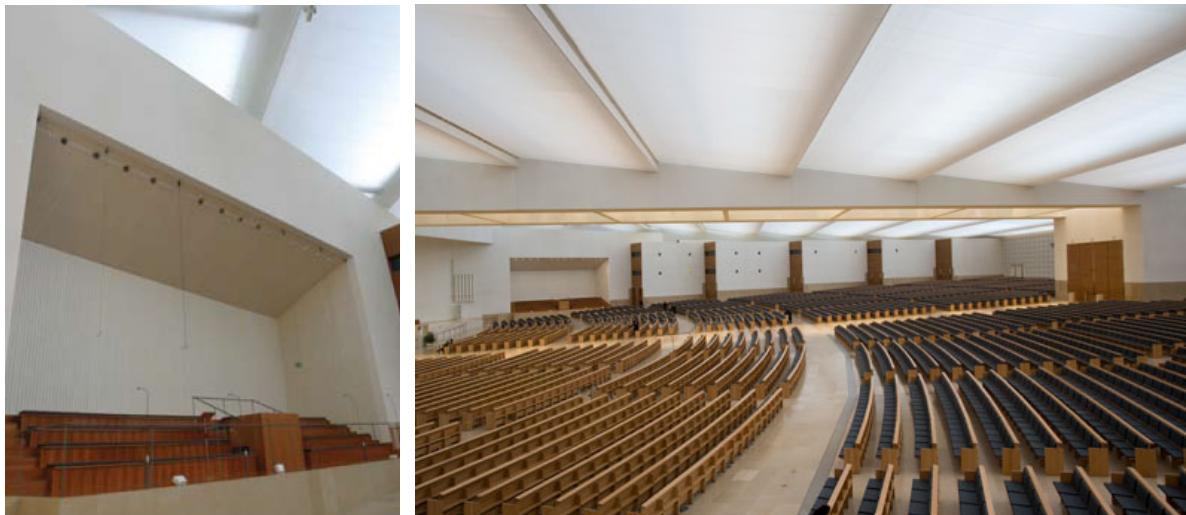
Figure 6 and 7 – Choir rear wall (left) and church overview (right).

In a church of this dimension (Fig. 7) and with the chosen coverings (for instance the marble on the floor), an acoustic disaster could be foreseen. However, strong measures were taken to oppose the unfavorable designed architectural characteristics of the church and to provide the space with the acoustic comfort demanded by the Owner. A very short list of some of these measures is presented:

- Pews in wood with acoustically tested soft cushions (fig. 4);
- Interior faces of the twelve entrance doors with a perforated wooden finishing (grouped resonators) (fig. 5);
- Choir rear wall and rear assembly wall with diffusers (fig. 6 and 8);
- Presbytery wall with a slight inclination;
- Sidewalls covered with acoustical material *Akustaplan* (fig. 9);

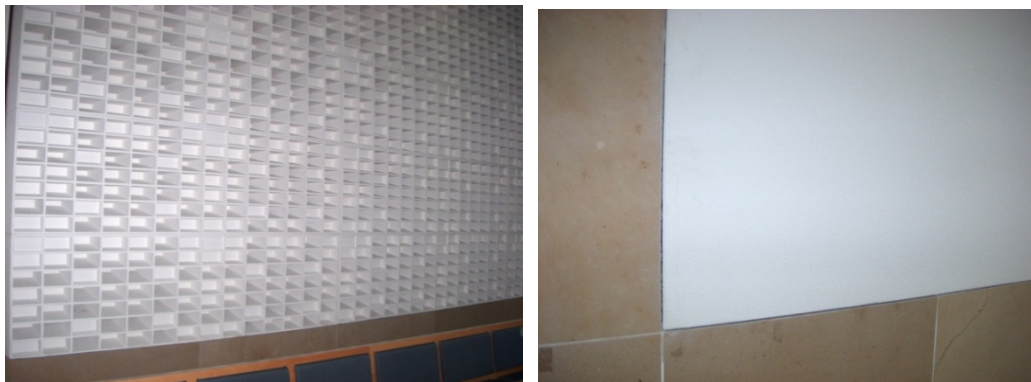
Figures 8 and 9 – Diffusers (on the congregation rear wall) (left) and wall with absorptive *Akustaplan* (white on photo at right).

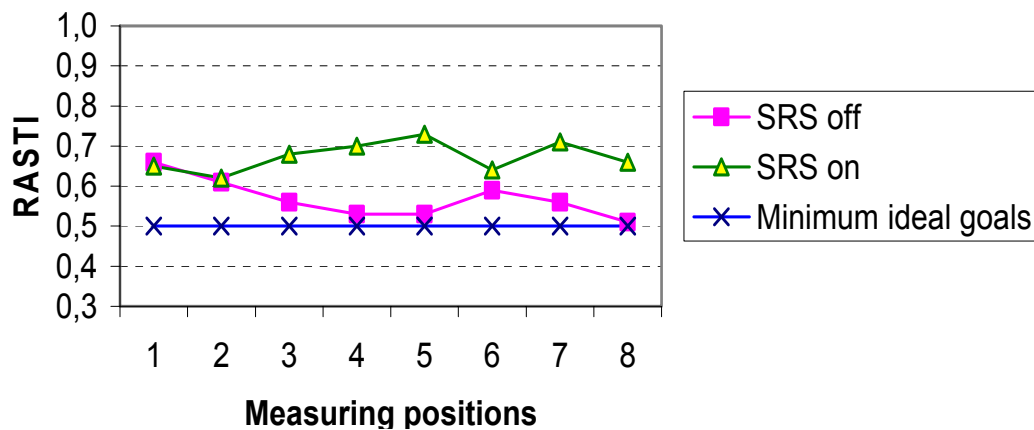
Figure 12 – RASTI values within the church with and without the SRS compared with the minimum ideal goals.

RASTI - The results regarding the RASTI (with and without the use of the church sound reinforcement system - SRS) are presented in Table 3 and Figure 12. On average the RASTI within the church is about 0.67 with the SRS on (an increase of 0.10 from the situation with the SRS off). These values show that the church has very good speech intelligibility and all the requirements set by the Owner are fulfilled.

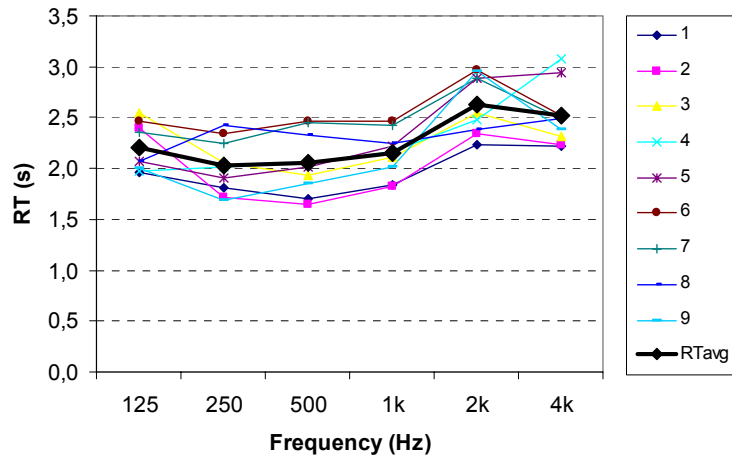
Figure 13 – Spectra of RT values in all the 9 measured points and the RTaverage

Reverberation time - The results regarding RT are presented in Table 4 and Figure 13. The 500-1k Hz RT values are between 1.7 and 2.5 s with an average of 2.1 s. Those values fulfil the ideal goals in 2/3 of the church and entirely for the acceptable limits. The 250 Hz RT values fulfil all the rules set.

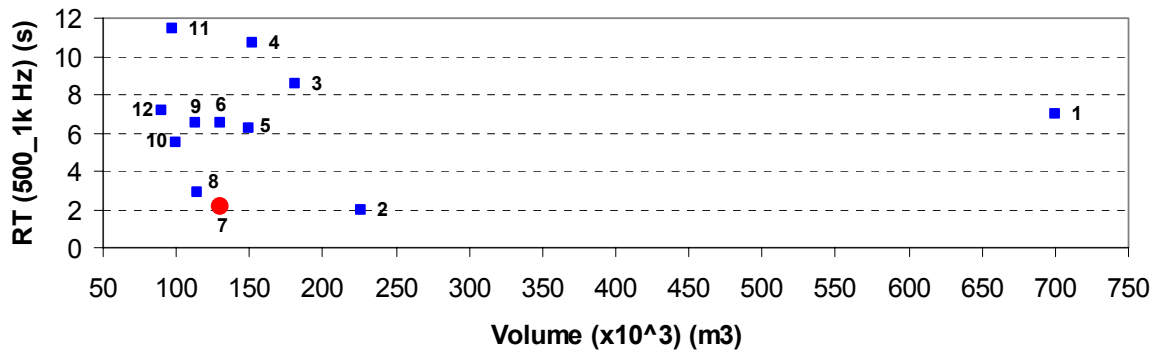
Figure 12 – Average RT (500-1k Hz) for twelve mega-churches (Fátima Holy Trinity: red dot).

Table 5 and Figure 12 show twelve mega-churches in the world, their volumes and RT_{500-1k} . Holy Trinity church (#7) is one of the largest but has almost the lowest RT only surpassed by the Church of Jesus Christ of Latter-Day Saints (this, however, not a Catholic church) built in 2000. The two smallest average RT values are in churches built in the last decade what means that there seems to be now a concern about the interior acoustics.
