Vibration-based damage identification of an unreinforced masonry house model

ABSTRACT: An unreinforced masonry house model was dynamically loaded using eccentric-mass shakers, with structural damage initiated by increasing the amplitude of the shaker load applied. At each damage state, a modal test was performed by impacting the house using a calibrated hammer. The structure's dynamic properties were extracted by Stochastic Subspace Identification techniques. Finally, two vibration-based damage indicators were applied to detect and determine the spatial distribution of damage, i.e. modal frequency variation and modal assurance criteria. It was concluded that prior to identifying the damage distribution, it was necessary to determine how the modal frequencies were related to each wall. Based on that individual wall information, only a rough identification of damage distribution can be achieved.

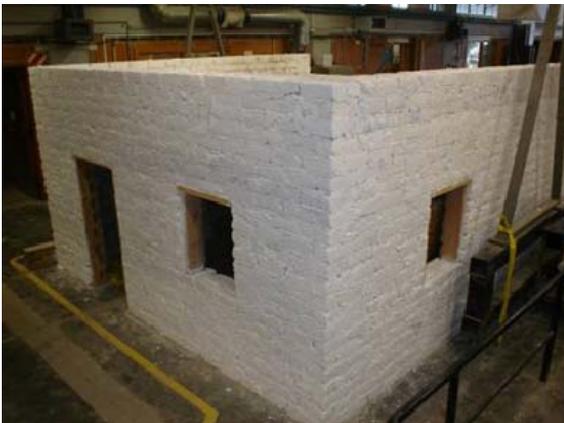
The house dimensions were 4 m × 4 m in plan. The north, east and west walls had a height of 2.2 m and a thickness of 230 mm (two leaves of bricks), whereas the south wall had a height of 1.9 m and was 110 mm thick (one leaf of bricks). The bricks followed a common bond pattern (header course at every fourth course). The east and west walls had one opening for windows and the north wall had two openings for a window and a door. There were no openings in the south wall. A general view of the house model is shown in Figure 1.

Figure 1. General view of the house model.

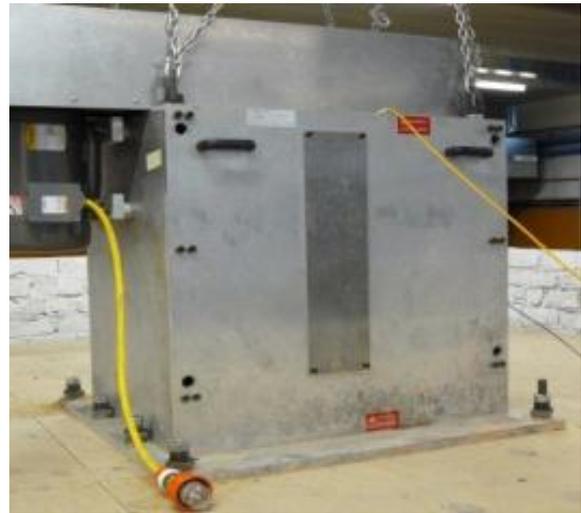
The unreinforced masonry house model was dynamically tested with the aim of determining the effect of damage on the modal response of the structure. An eccentric-mass shaker (ANCO MK-140-10-50) attached to the roof diaphragm was used to damage the structure (Figure 3). The purpose of using a shaker to damage the house model was to produce a random, but controlled, deterioration that could then be detected by the damage identification procedures under investigation.

Figure 3. Eccentric mass shaker attached to the diaphragm.

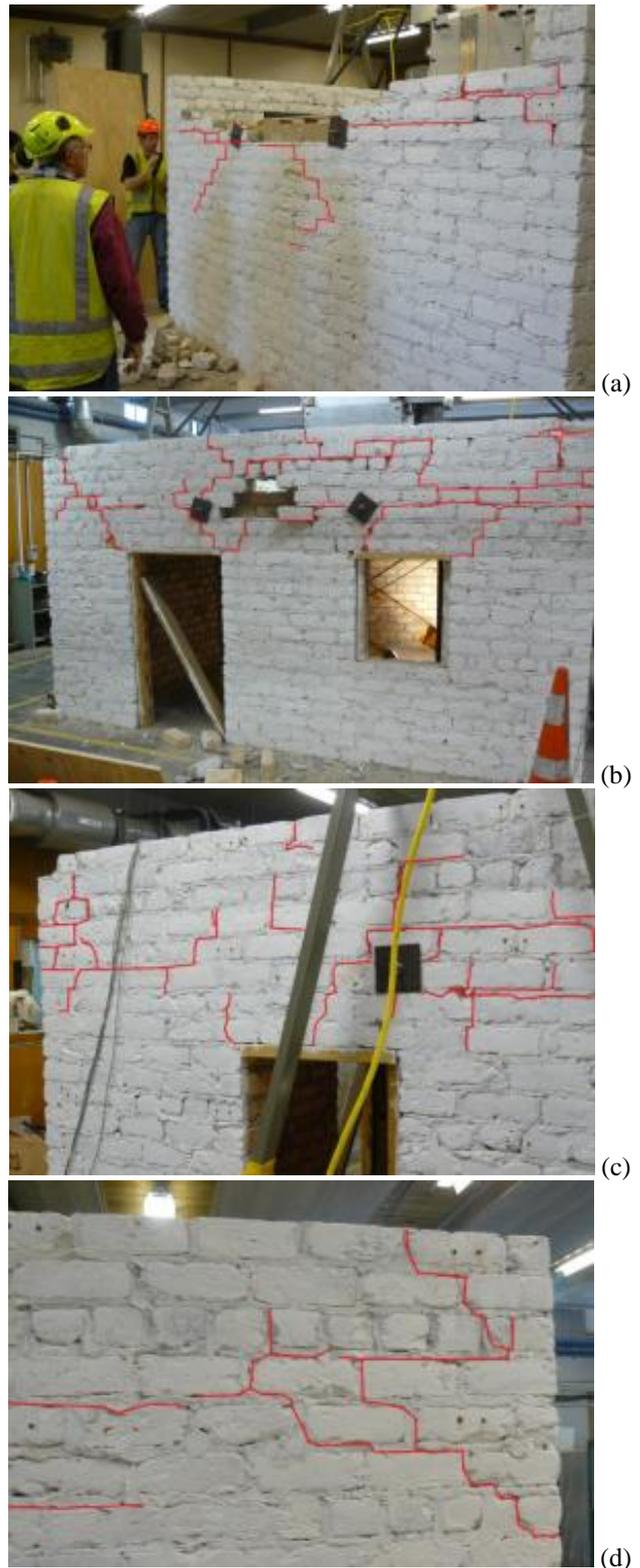
The final excitation sequence (ES4) produced severe damage, especially in the north and south walls (DS4). In the south wall, the two upper brick courses fell down and diagonal cracks typical of wall out-of-plane failure were developed (Figure 5a). The parapet of the north wall was heavily damaged, even losing some bricks. The cracks around the door and window openings that had been previously detected now became wider and new cracks were also identified (Figure 5b). Cracks were noticed around the window openings of the east and west walls, but the most significant damage was observed in the upper corners of those walls, probably because of the effect of the out-of-plane failure of the north and south walls (Figures 5c and 5d).

Figure 5. Damage observed at DS4. (a) South wall, (b) North wall, (c) North-west walls' corner, and (d) South-west walls' corner
