## RE-INFILTRATION REPAIRS OF COMPOSITES IN CIVIL AVIATION

This work deals with a re-infiltration repair procedure for fibre reinforced plastics potentially applicable to components used in civil aviation. Based on Compression-After-Impact (CAI-) testing, it is shown that the re-infiltration repair approach exhibits the potential to extend its field of application from cosmetics to structural repairs. As not only mechanical issue but also the fulfilment of certification standards is one major key for establishing a new repair procedure in civil aviation, the chance to achieve certification regulations as well as the corresponding development steps are discussed.

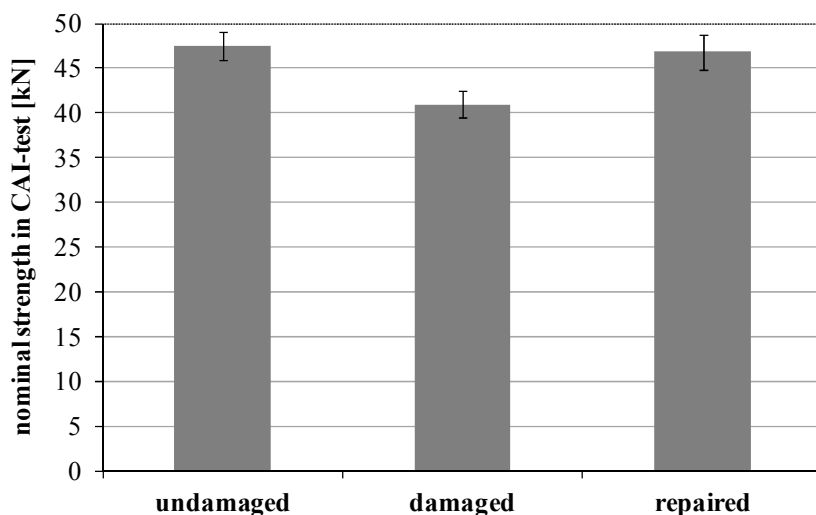
Fig. 1 - Results of Compression-After-Impact test for undamaged, damaged and repaired specimens

resin formulations with very low viscosities allowing better fillings of delaminations (cp. e.g. [Thunga, 2013]). These works are the starting point of this article. It is shown that the re-infiltration repair can also be used to restore sample strength in CAI-tests not only for energy levels around BVID but also for higher impact levels where no complex sample preparation for resin infiltration is needed (see Fig. 1). As the certification aspect is one major key for establishing re-infiltration repairs for structural components in civil aviation, the certification requirements are discussed and potential research steps to achieve them are illustrated.
