PAPER REF: 6724

LABORATORY TESTS ON FAILURE BY OVERTOPPING OF EARTH DAMS. IMAGING TECHNIQUES USED FOR EXTRACTION OF EXPERIMENTAL DATA

Sílvia Amaral^(*), Teresa Viseu¹, Rui M. L. Ferreira²

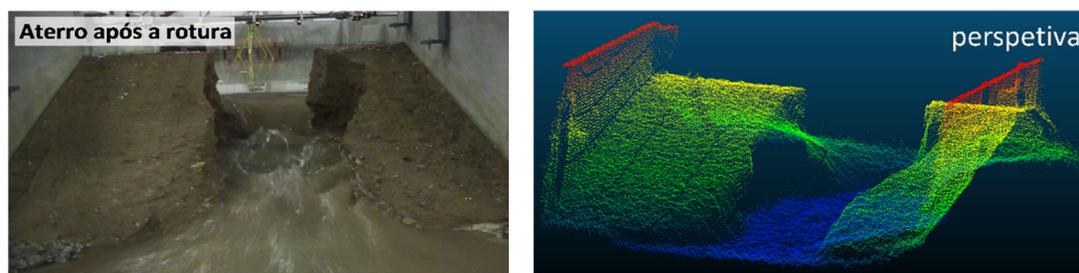
Fig. 1 - Reconstruction of the surface of the failed earth dam. Left - failed dam; right - point cloud of the reconstructed dam morphology

Kinect sensor was successfully used in the 3D reconstruction of the earth dam (Figure 1).
