ADHESIVE JOINTS INTEGRITY MONITORING USING FIBER OPTICS SENSORS

Chow-Shing Shin^{1(*)}, Yi-Jui Yang¹ and Shien-Kuei Liaw²

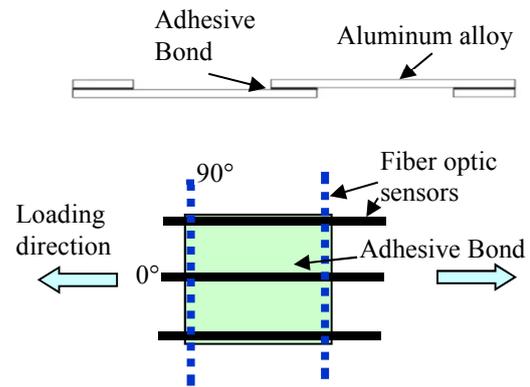
Fig. 1 - Schematic diagram showing how the fiber optics sensors are embedded in the adhesive joint.

Optical fibers with FBG are embedded at either 0°, or 45° or 90° in the lap joint as schematically shown in Fig.1. The specimens were subjected to tensile or cyclic loading. Periodically, the specimens were unloaded to 400 N and 0 N to allow the reflected light spectra from the FBGs to be recorded using an optical spectrum analyzer. These spectra were compared with the original spectra at the respective loading before testing. A parameter to quantify the shape change of the FBG spectrum is proposed as an indicator of damage occurrence.

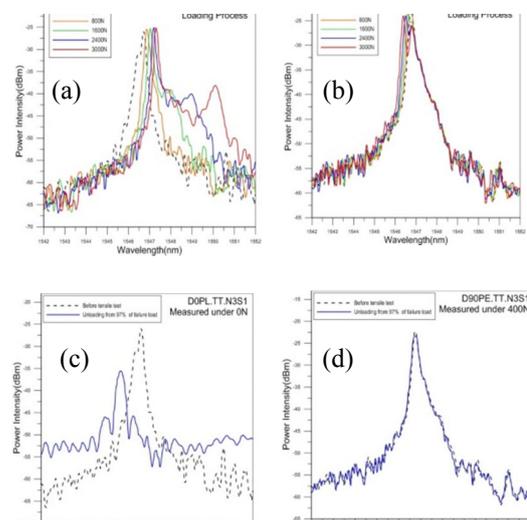
Fig. 2 - (a) 0°; (b) 90° FBG spectra at progressively increasing load; (c) 0 N spectrum of 0° FBG spectrum; (d) 400N spectrum of 90° FBG after unloading from 97% of failure load.

Typical FBG spectra at different loadings are shown in Figs.2a and b. The shift in wavelength is caused by a general increase in strain on loading up. The widening and splitting are caused by the appearance/aggravation of non-uniform strain distribution. The latter may be the result of strain concentration near the edge of the joint. It can also be caused by internal damages. Strain concentration effect may be eliminated by unloading to zero load. If the widening and splitting of the spectra still persists (Figs.2c and d), then it should be brought about by internal
