Documentation, Restoration and Reuse of Heritage

2-4 November 2022
Porto, Portugal

BOOK OF EXTENDED ABSTRACTS

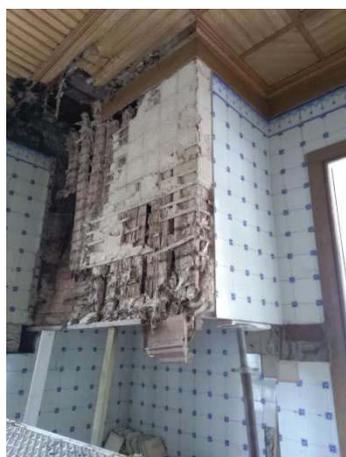
Figure 4 – Leaks through the roof, chimney, kitchen (credits: Aníbal Costa)

In all constructions, it is essential to avoid the ingress of water, either above (roof) or below (rising damp) to avoid future problems in the durability of materials and structures. In this case, there were several problems associated mostly to leaks through the roof in singular volumetric intersections and through rising damp due to absence of drainage water system, Figures 4 to 6.

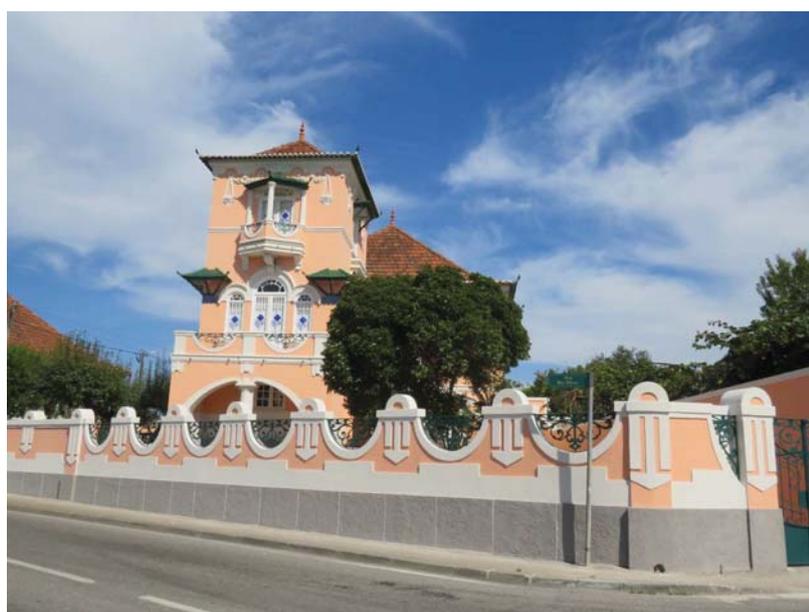
Figure 10 – Cestinhos house at the end of minimum intervention (credits: A. Tavares)

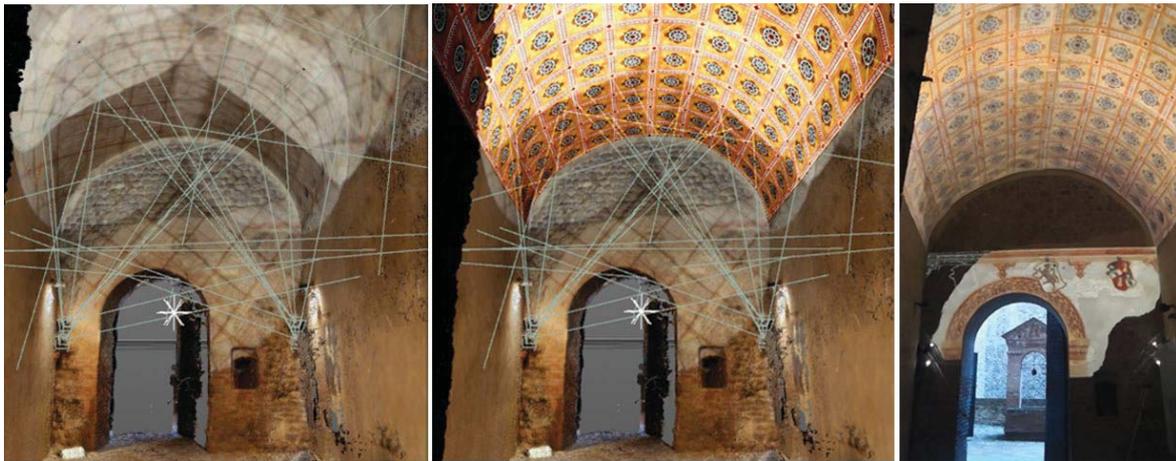
Figure 6. Reconstruction of the lacunars of the barrel vault made on the basis of the texture obtained through the cylindrical projection (UV mapping). Reconstruction of geometries and decorations Stefano Giannetti; Artistic and pictorial reconstruction Natalia Gurgone, Laura Vignoli.

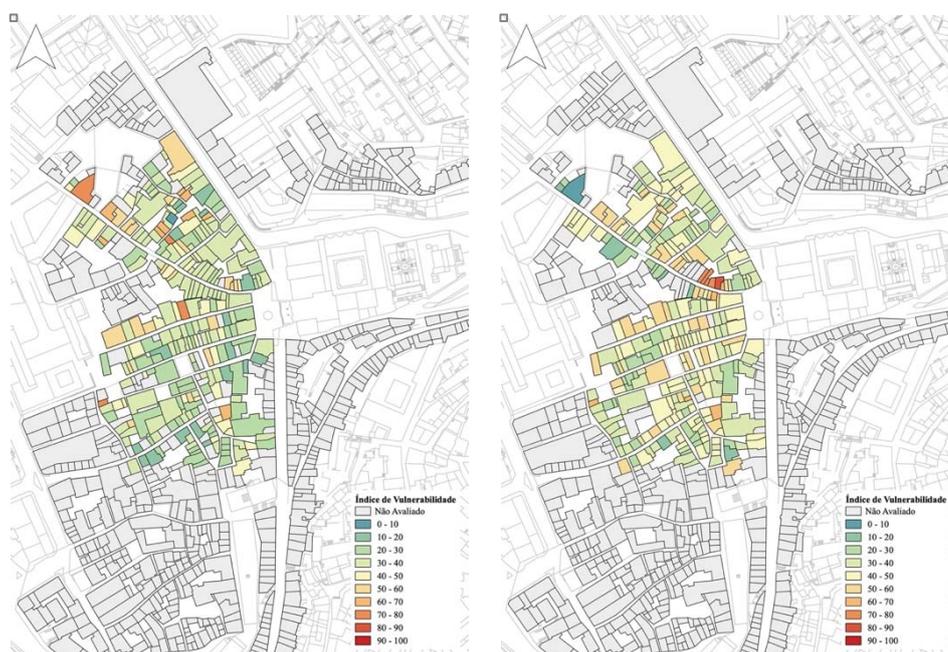
Figure 1. Seismic vulnerability index for 2009 (a) and 2021 (b).

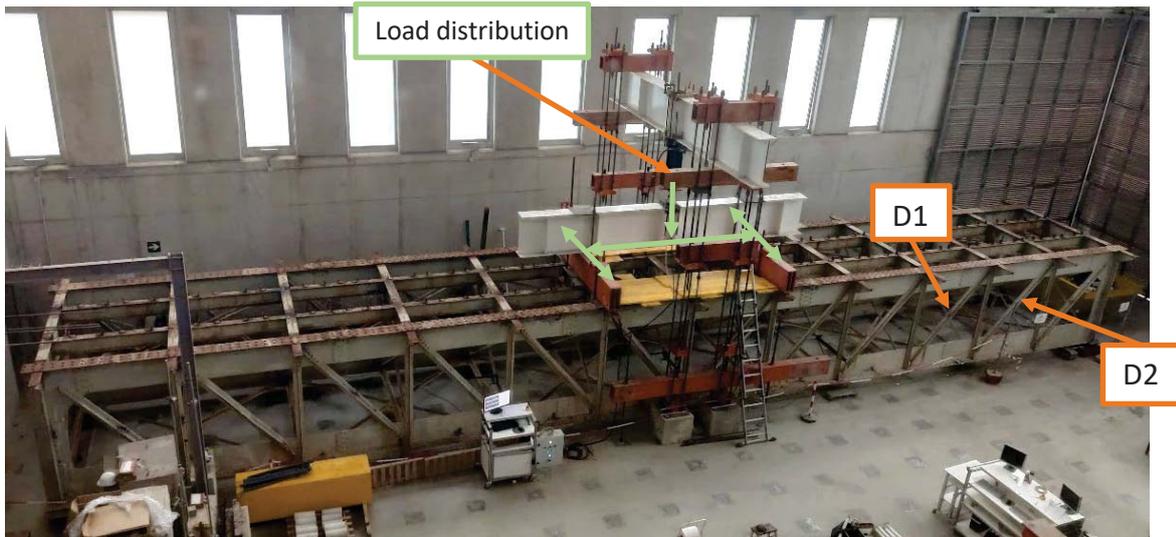
Figure 2. Test setup.

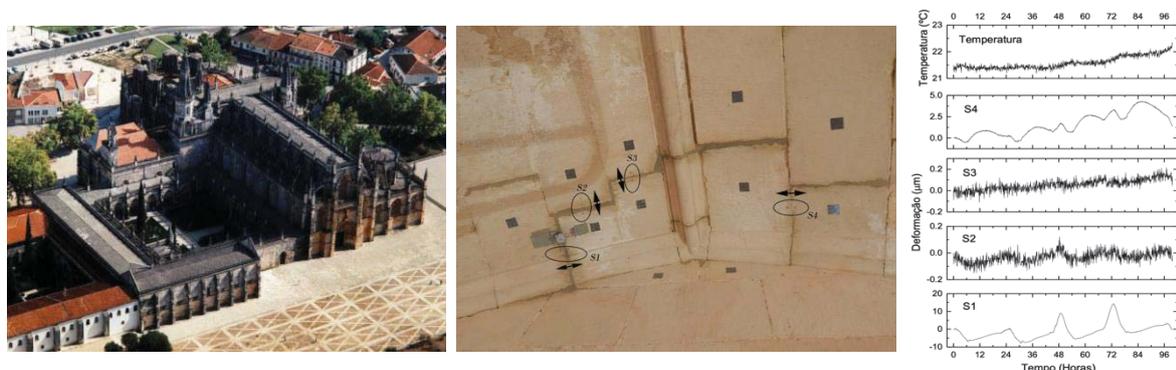
Figure 1. Monastery of Batalha (left); Sensors implementation (center); Monitoring results (right)

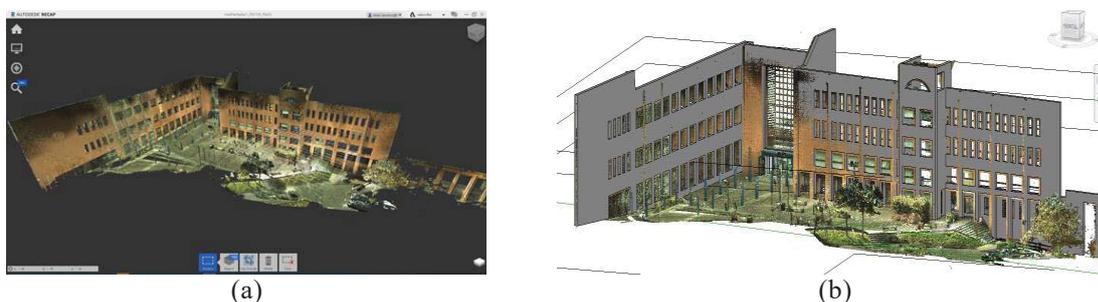
Fig. 2: (a) Point cloud in Autodesk Recap; (b) View of the HBIM model with the integrated point cloud.
